Monitoring Data Record

Project Title: B-4183	
COE Action ID: 2011-00417 DWQ Number: 20110060	_
Stream Name: Crooked Creek and Middle Fork Creek	
City, County and other Location Information: Madison County, replaced Br. #29 over Midd	le
Fork Creek and Br. #28 over Crooked Creek on SR 1526 adjacent to US 19	
Date Construction Completed: Completed Planting on 11-26-12 Monitoring Year: (4) of 5	
Ecoregion: Broad Basins 8 digit HUC unit 06010105	
USGS Quad Name and Coordinates: 35.85350, -82.48853	
Rosgen Classification:	
Length of Project: 107' Urban or Rural: Rural Watershed Size: 7.6 sq. mi.	
Monitoring DATA collected by: M. Green & J. Young Date: 7/8/15	
Applicant Information:	
Name: NCDOT Roadside Environmental Unit	
Address: 1425 Rock Quarry Road Raleigh, NC 27610	
Telephone Number: (919) 861-3772 Email address: mlgreen@ncdot.gov	
Consultant Information:	
Name:	
Address:	
Telephone Number: Email address:	
Project Status: Complete

Year 4 – July 2015

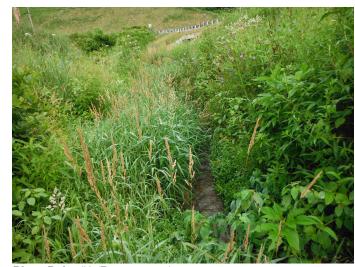
Overview Photo Looking Downstream of Crooked Creek from Crooked Creek Rd
